# MURALS, STONE, AND ROCK ART WORKING GROUP NEWSLETTER

November 2025, No. 4

### **Rock art sites of Gwaram and Birnin Kudu, Jigawa State, Nigeria: loss of Atiye/Zango rock painting**

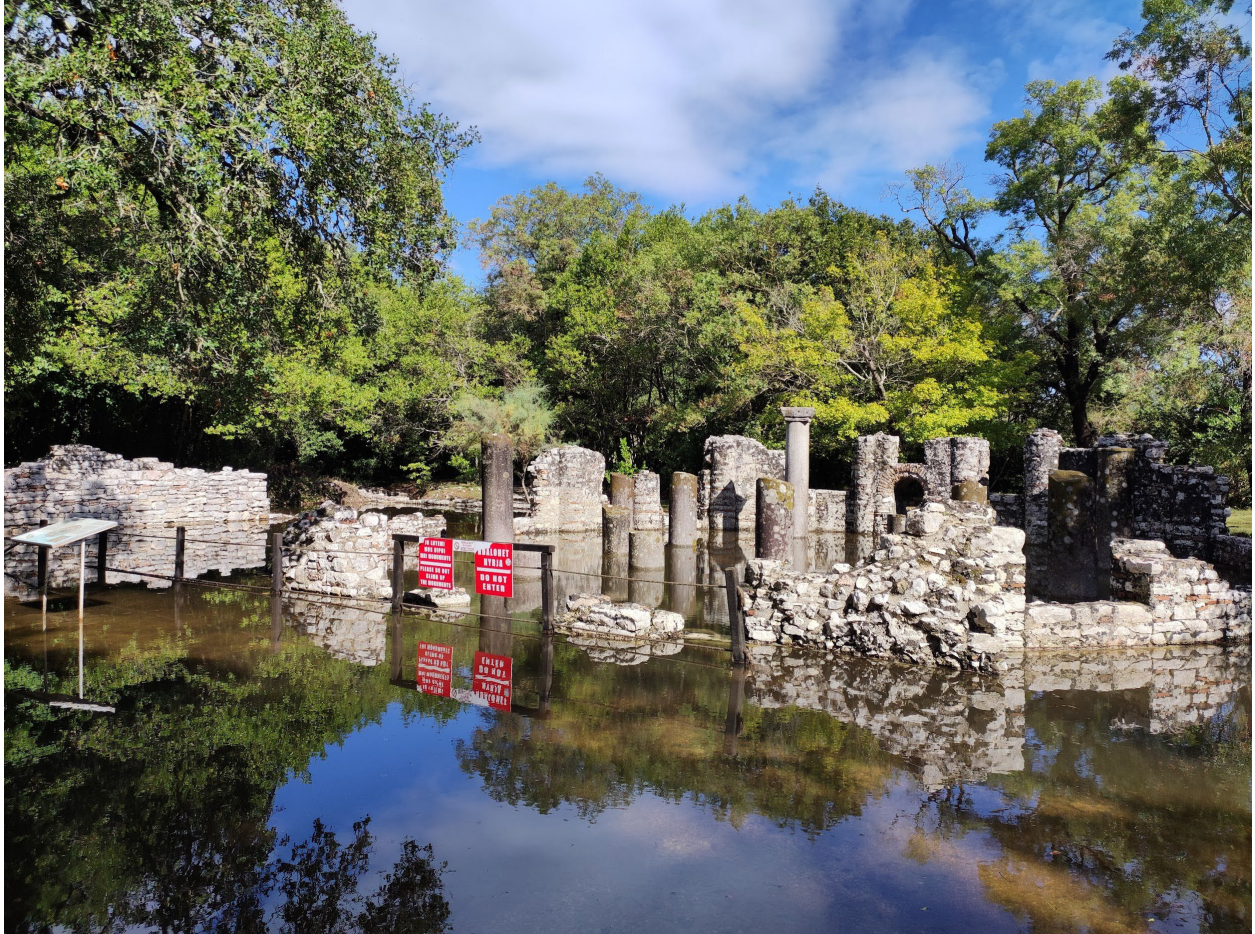
The Baptistry of Butrint (Albania), whose mosaic floor is kept covered for conservation purposes. The monument appears flooded as a result of heavy rainfall.  
(Photograph: © *Evjeni Mato*, October, 2021)

Evjeni Mato, conservation manager from the Butrint Management Foundation, started off the meeting with a presentation on the impacts of climate change on the archaeological site of Butrint, Albania, which is included on the World Heritage List and is also recognized as a National Park for its natural values. Her study was focused on the specific conservation issues at the site related to sea level rise, with some areas of the site with mosaic pavements being flooded permanently, and others experiencing periodic flooding (see image below). Related to this is the issue of salts from the Ionian sea, which is adjacent to the site. Butrint has also experienced drought and heat waves in recent times. Actions that the site managers are considering to mitigate damage being caused by climate change, include continuous monitoring, reuse of ancient drainage systems and new drainage systems as hydrology plays a key role at this site. Additionally, lightweight shelter structures are being considered. Sustainability is of primary concern to respect the natural and cultural values of this complex site, which are intimately connected through hydrology of the site.

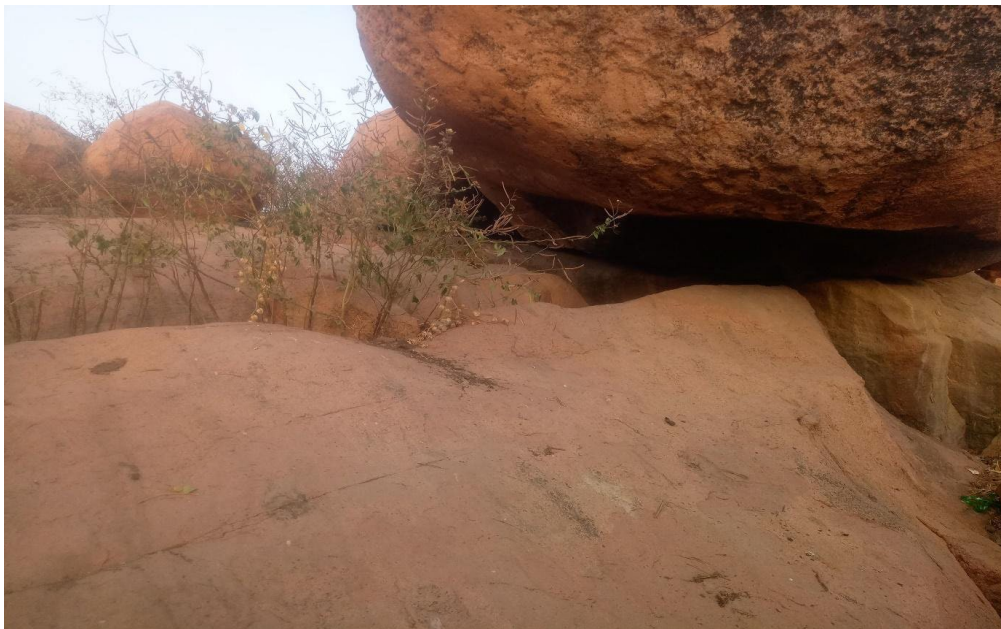
**Atiye/Zango** is located at the east side of Birnin Kudu. The site is secured with fencing but is surrounded by settlements of Birnin Kudu peoples or community. In 2019–20 the site started to be used for the dumping and burning of refuse. This has had severe, negative effects on the site including blocking access to areas of rock art and the deposition of soot and partially combusted material on the surface of the rock art.

Atiye rock painting site

This undesirable turn of events could only occur through negligence of the guardians of the site and disregard of elements of the local community. A detailed analysis of the events and causes leading to this loss may help to prevent loss of other sites similarly at risk from incursion.

The rock art sites described above each face a variety of threats. However, in the case of Atiye/Zango, threats from encroachment of local settlements have resulted in catastrophic damage to this important site. This loss occurred during a period in which the Rock Art Interpretation Centre and National Headquarters were unable to carry out physical visitations and monitor conditions of the sites. As a result of the financial crisis the country is facing, the commission budget is insufficient to take adequate care of the many rock art sites of the region.

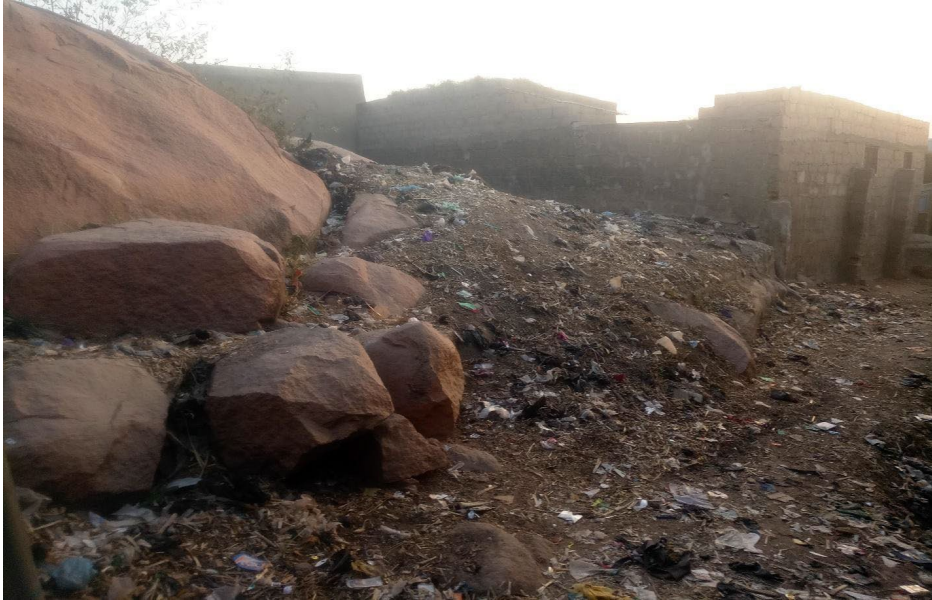
Encroached entrance and use of site as refuse dumping ground  
(Photograph: *Abdullahi Abdulkadir*, 2025)
