JOINT INTERIM MEETING OF FIVE ICOM-CC WORKING GROUPS:

Refectories in the Castle of the Teutonic Order in Malbork - Discussion on the permissible range of conservation and restoration works.

Marcin Kozarzewski and Agnieszka Wielocha

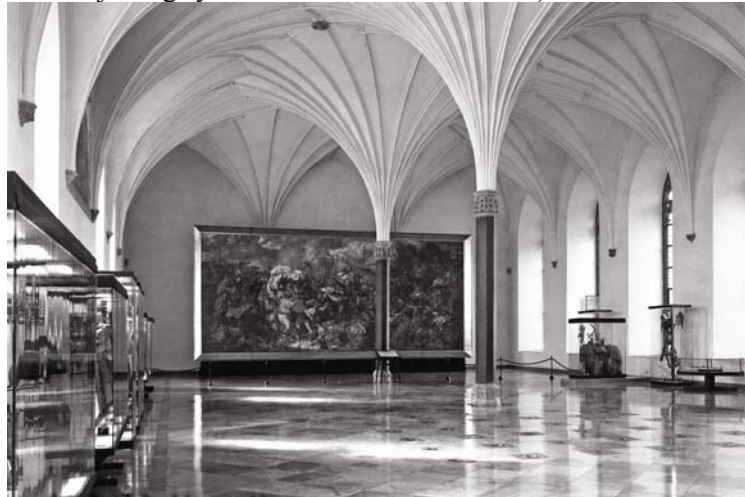
Figure 1: The exhibition of “The Battle of Grunwald” by Jan Matejko in The Great Refectory in 1977. Photography from the archive of The Malbork Castle Museum.

Prussians”, one could now see an iconic Polish painting - “The Battle of Grunwald” by Jan Matejko, showing the famous 1410 battle in which the Order suffered a fateful defeat (Figure 1).

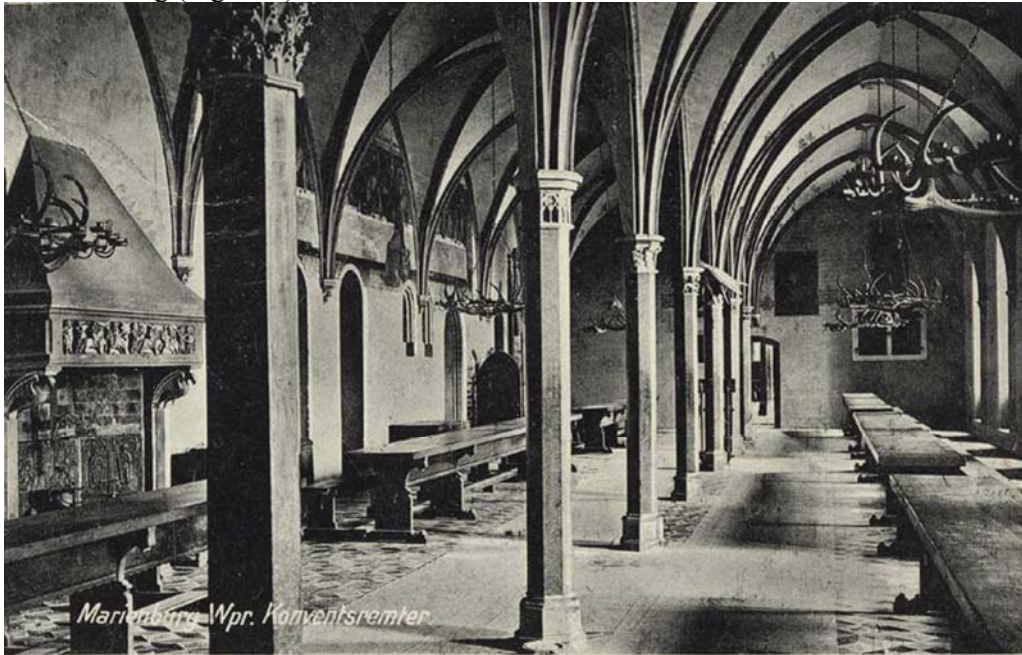
Figure 2: The Convent Refectory at the turn of the 19th century.
Postcard from the archive of The Malbork Castle Museum.

In 1894 the east wall of the Refectory was decorated with the coats of arms of the Kaiser, his consort and the king of Wirttemberg (Figure 2).

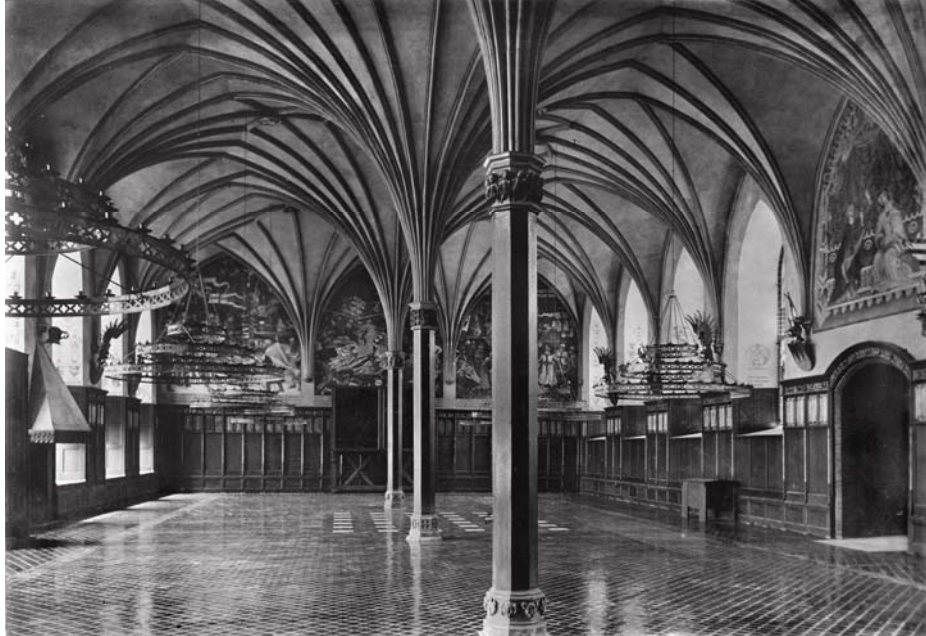
Steinbrecht's work in the Great Refectory is particularly interesting because of its wide scope. The paintings he commissioned corresponded with earlier Gothic decoration, the remainder of which he found in the middle arcade of the north wall. It was a three-part composition depicting the Order's raids into the Old Prussia. Style-wise, the new scenes were in line with the former Gothic paintings, but showed the conquest of the pagan Old Prussia by the Order as a national war. Steinbrecht's creation, realised after the outburst of the 1st World War, was an apotheosis of mission and conquest. The imperial ideology and its drive to impose German civilisation on the people of Vistula Lagoon area, was at the heart of Steinbrecht's decoration design in the Great Refectory (Figure 3).

Figure 3: The Great Refectory in 1916, after the end of the Steinbrecht's works.
Photography from the archive of The Malbork Castle Museum.

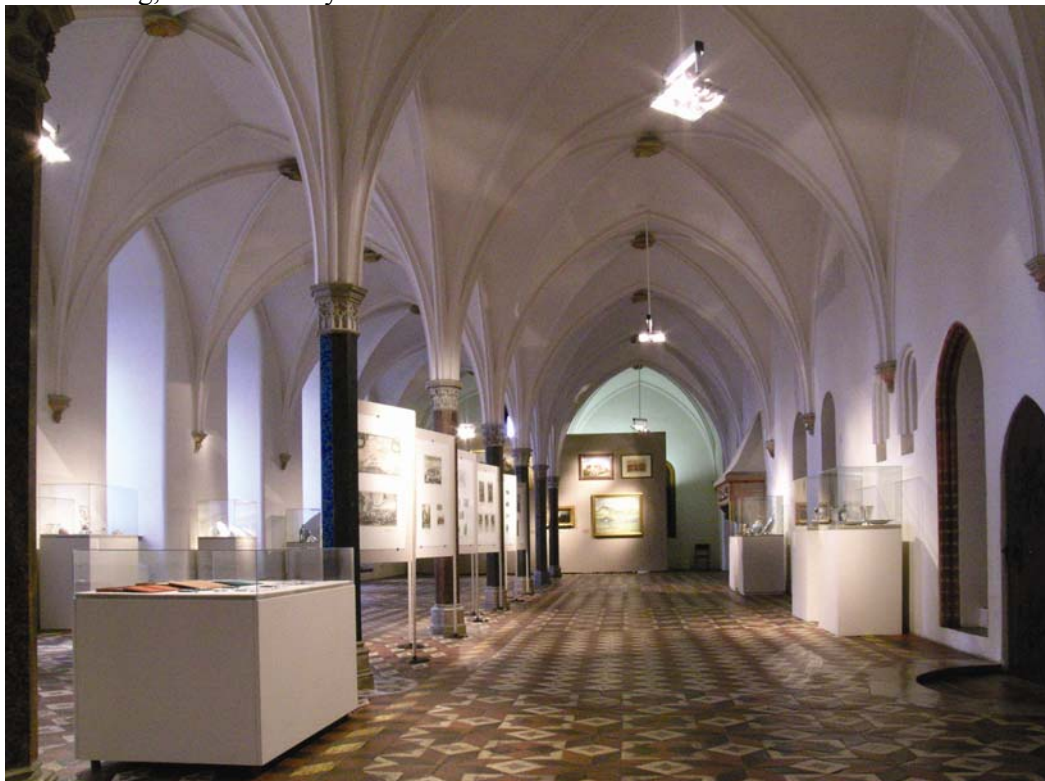
Until 2005 the whole decoration of the walls and ceiling of the Refectory was covered by white paint (Figure 4). The main damage was caused during the preparation process prior to overpainting in the 1960s. The paintwork became discoloured all over and the highlight modelling was lost. Recent treatment included removal of white overpaint, the restoration and partial reconstruction of Steinbrecht’s plasters and paint layers of the ribs. The ‘Last Supper’, painted in 1896 by Hermann Schaper, was gradually reintegrated and the main scene of Christ and the Apostles highlighted by setting it out against a darker background. The restoration of nearly completely indistinguishable parts of the painting, such as the faces of a few Disciples, their hands or the items on the table posed a particular difficulty. Detailed photographs were not available and a sketch by Schaper for the ‘Grand Masters’ Homage’ was used to paint the faces and hands of the Disciples. The techniques of transformation and imposition of photographs were used here.

Figure 4: The Convent Refectory before the beginning of conservation and restoration works in 2005.

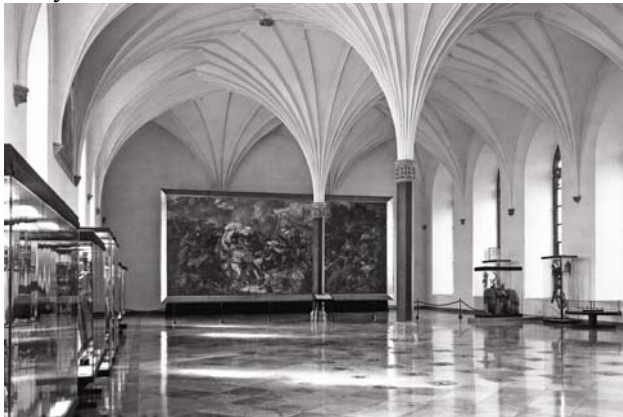
Figure 5: The Convent Refectory in 2006, after the end of conservation and restoration works.

Crucial for the reconstruction of the furniture, especially the tables from the Refectory, were Steinbrecht’s original design, saved fragments, which underwent dendrochronological tests, and pre- and post-war photographs. Experts examined similar medieval tables that served as models for Steinbrecht’s design, located in Lueneburg, Lower Saxony.

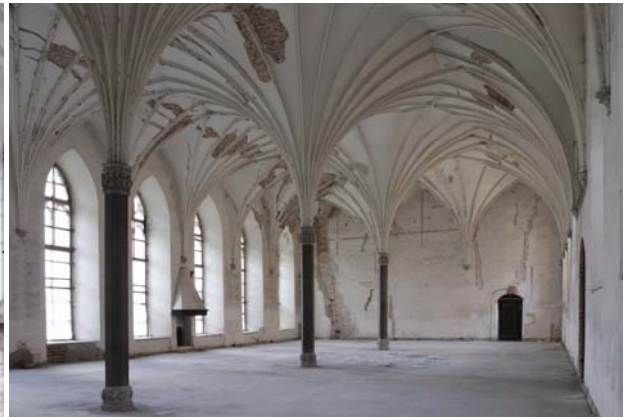
The walls and ceilings of the Great Refectory, as mentioned earlier, were regularly painted white from the 1960s (Figures 5-6). An important exception was the painting of the Coronation of the Blessed Virgin Mary.

Figure 6: The Great Refectory before the beginning of conservation and restoration works in 2005.

Archival documentation was gathered and re-filed. Old photographs provided valuable material for comparative research and restoration work. Old coats of white paint were removed from the Refectory's walls and ceiling. Figurative paintings, coats of arms, polychromes on the vault ribs, render, in fact all the effects of Steinbrecht's programme were exposed and restored or reconstructed.

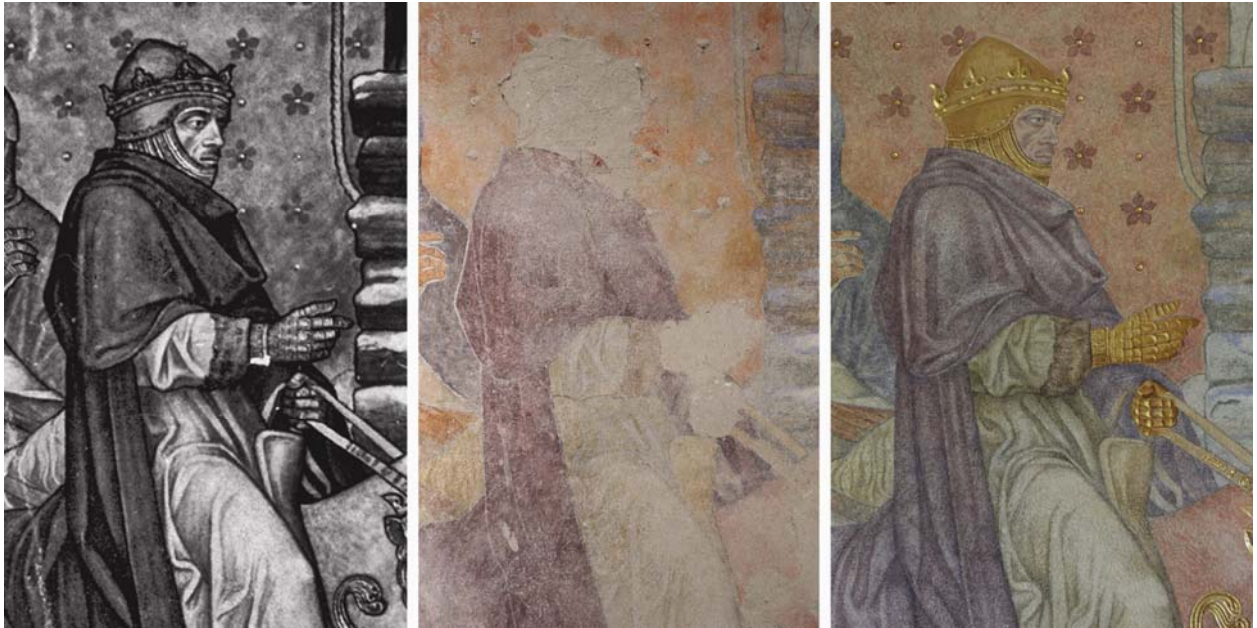
Figure 7: Detail of Hermann Schaper's painting on the north wall of The Great Refectory. From the left – in 1916 (photography from the archive of The Malbork Castle Museum), after the cleaning, after the end of the reconstruction works.

All the work carried out was precisely documented with photographs and drawings. Additionally, tests were done on the historical mortar and historic paint layers. Six figurative paintings executed by Hermann Schaper and August Oetken on the northern and southern walls were exposed, cleaned and consolidated. Based on archival records, gilded relief elements and missing parts of the composition were reconstructed (Figure 7). When the paintwork on the north wall was being restored, the effects of wall movement were taken into account, as they affected the composition.
